# Nondestructive Evaluation (NDE) Techniques Assessment for Graphite/Epoxy (Gr/Ep) Composite Overwrapped Pressure Vessels

30 October 1998

E. C. JOHNSON and J. P. NOKES Mechanics and Materials Technology Center Technology Operations

SPACE AND MISSILE SYSTEMS CENTER AIR FORCE MATERIEL COMMAND 2430 E. El Segundo Boulevard Los Angeles Air Force Base, CA 90245

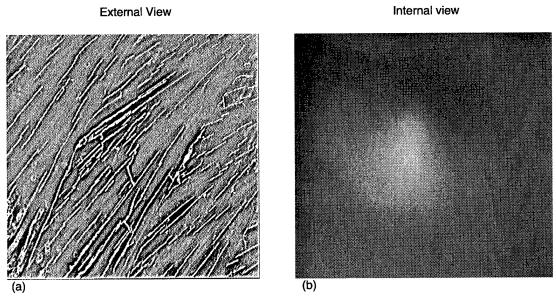
As can be noted from Figure 4a, the outside Gr/Ep surface of the COPV exhibited little, if any, indication of the impact. However, Figure 4b reveals that on the inside liner surface a small dent is very apparent. One can surmise, therefore, that the impact damage at this energy level evolves in the manner depicted in Figure 5; the composite overwrap flexes into the metallic liner to accommodate the impact and then returns to its pre-impact position. The liner, on the other hand, is left dented and locally unbonded from the overwrap. It thus should be strongly noted that a visual inspection of the exterior of the COPV will not serve to detect this type of damage. It should also be noted that if the impact has weakened the composite (broken fibers etc.), there is no obvious visual sign. The presence of the dent in the liner is critical for obtaining satisfactory results for a number of the impact damage detection techniques presented in the balance of this report. This is an important observation.

Figure 4. Visual indications of a 35-J impact damage site on spherical vessel. For the external view, dye penetrant was used to enhance the image.

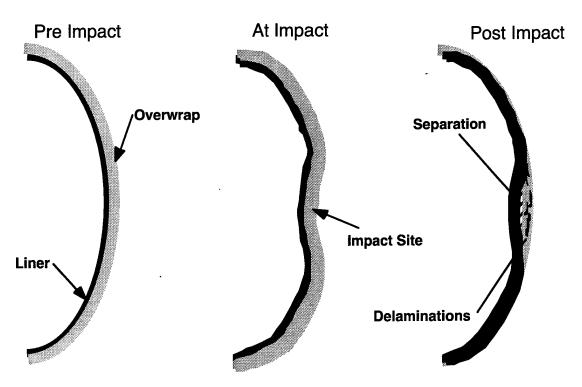
Figure 5. Cross-sectional view of the impact damage event.

It was also noted during this study that, in some instances, repressurization of an impacted COPV caused the dent to disappear. In other words, for some inspection techniques, the effects of an impact can be erased by pressurizing the bottle!

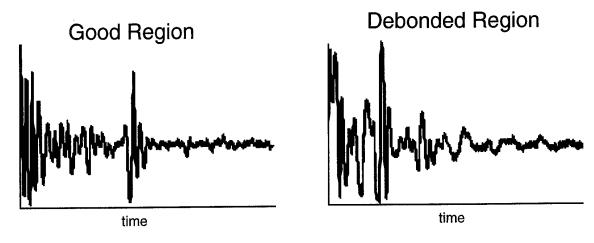
As one might expect, the type of damage described in Figure 5 can be detected using a handheld pulse-echo ultrasonic probe on the outside surface of the COPV. In the region of impact, the ultrasonic pulse returns early because the sound cannot bridge the gap to the dented liner. Damage within the composite results in a decrease in signal amplitude, which can also be detected in some circumstances. A comparison of a typical waveform recorded on an impact site and on an adjacent nominal site is presented in Figure 6.

Figure 6. Pulse echo A-scans from a good and debonded region of an impacted COPV. The measurements were made using a 10-MHz transducer and Ultragel II<sup>TM</sup> couplant. Note the strong (early) response from the backside of the overwrap in the debonded region.

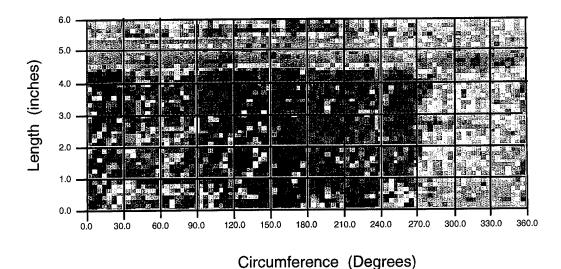
To eliminate variances associated with the hand coupling and positioning of transducers, the impacted COPVs were inspected using both a through-transmission and a pulse-echo ultrasonic technique. In both instances, the COPVs were immersed in and filled with water. For the through-transmission technique, a sound pulse generated by one transducer was received by a second after passing completely through the COPV. For the pulse-echo technique, a reflection rod was inserted into the center of the COPV. In both instances, the amplitude of the 5-MHz pulse was recorded as a function of position after passing through the wall(s) of the COPV. The data revealed that ultrasound can be used to detect non-visible impact damage in COPVs. A C-scan representation of a 10 cm x 23 cm COPV after a 10-J impact is presented in Figure 7. Though the impact left no visible indication on the surface of the COPV, the impact site is clearly visible in the central section of the C-scan image.

Figure 7. C-scan image of a 10 cm x 23 cm COPV after a 10-J impact. The impact site gives rise to an obvious, somewhat circular indication centered at about (125°, 1.5 in). The rectangular indication on the right was due to a label affixed to the bottle. The stripe along the top of the scan was due to the curved edge of the bottle.

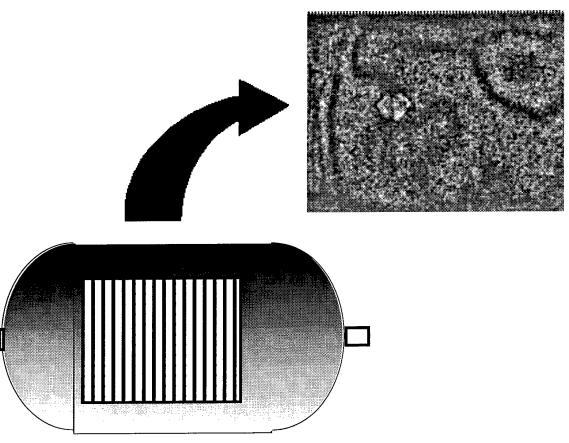
Figure 8. Shearographic image of 35-J, 25-mm tup impacted cylindrical COPV.

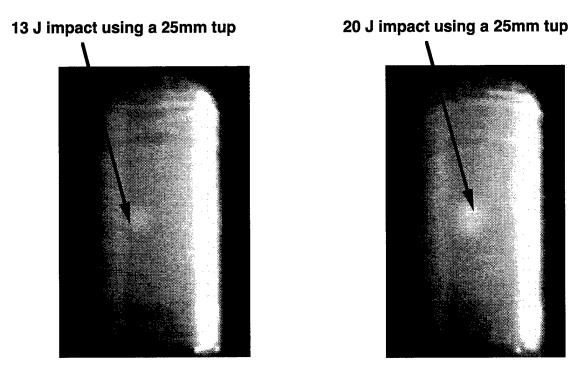
The successful application of thermographic techniques can be affected by the structure of the vessel. It was noted that impacts of less than 45 J gave rise to clear thermographic indications for the spherical vessel included in this study (Figure 11). It might also be noted that similar tests were conducted on several spherical vessels not included in this report, and that 50-J impact sites were not detectable. These vessels had slightly thicker overwraps and/or liners.

Figure 10. Comparison of thermographic indications on a 10 x 23 cm COPV following distinct 13-J and 20-J impacts.

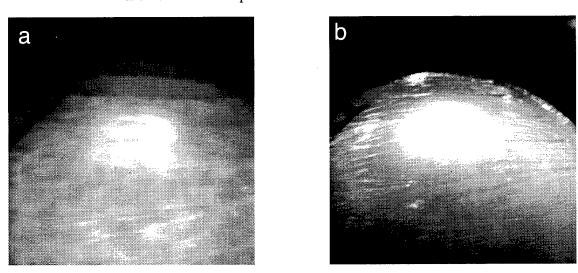
Figure 11. Thermographic image of a 45-J impact site on the spherical COPV. These images were obtained using an Amber Radiance 1 IR camera (3–5  $\mu$ m). The image labeled (a) was acquired ~1 s after the surface was flashed with a high-intensity flash lamp. The image labeled (b) was acquired ~5 s after the surface was warmed with a quartz heat lamp.

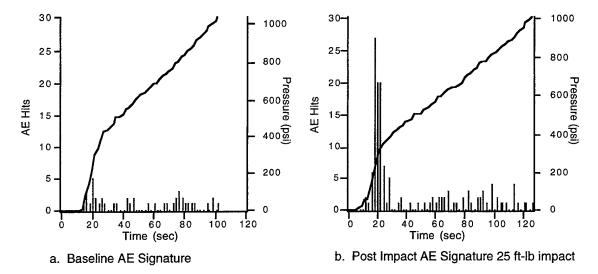
For this investigation, an array of six AE sensors were used to record the acoustic activity of a vessel during pressurization. These transducers were coupled to the COPV with an ultrasonic couplant. COPVs exhibit the Kaiser Effect, <sup>12</sup> which implies that once a structure has experienced a stress level, no new AE will occur again until that stress level has been exceeded, unless, of course, the structure has been damaged before being repressurized. To detect impact damage, the COPVs were subjected to an initial AE screening, and then pressurized again after being subjected to an impact. Changes in the acoustic activity were noted with the COPVs exhibiting significantly more AE events after impacts that exceeded a particular energy threshold. The energy threshold required for AE monitoring to detect an impact varied significantly between vessel types, ranging from 10 J for the small cylindrical COPV to over 20 J for the larger cylindrical vessel. Figure 13 demonstrates the change in AE activity that occurred after a 35-J impact on the 10 x 23 cm cylindrical COPV. In Figure 13a, little AE activity is noted since no damage to the vessel occurred between the original manufacturer's proof pressurization and the AE screening test. Figure 13b reveals a significant increase in AE—clearly indicating a change in the COPV structure as a result of the impact. AE monitoring, however, does not provide a quantitative means for ascertaining the severity of the impact damage. Instead, AE methods appear to offer excellent potential as an impact screening technique. The AE system employed in this study was fairly rudimentary, allowing only for the capture and analysis of several parameters that characterize the acoustic emissions. Emerging technologies that permit a modal analysis of the captured waveforms offer potential for significant improvements in the impact screening process.

Figure 13. Acoustic emission data for for the 10 x 23 cm cylindrical COPV (a) before and (b) after a 35-J impact.
